M/V Hanjin Pennsylvania: Explosions at Sea

Charles P. Weeth
Weeth & Associates, LLC
122 S 17th St.
La Crosse, WI 54601-4208 USA

Final Report - Pictures

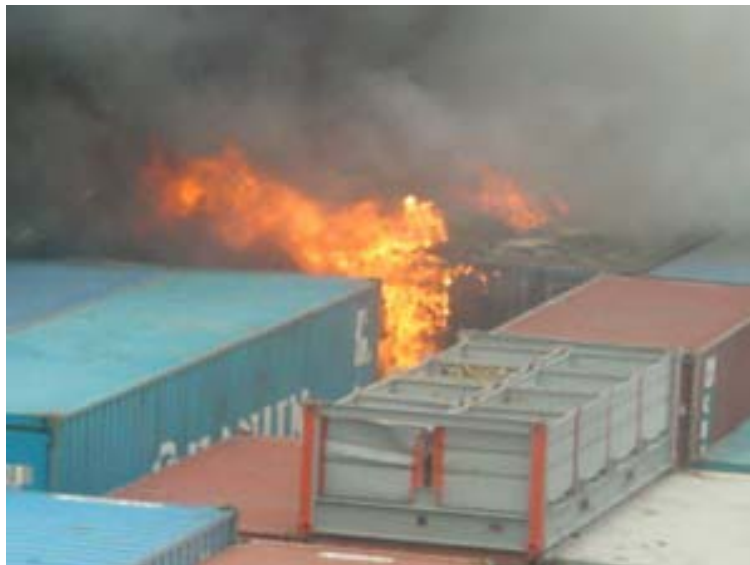
Photo 2. November 11th. Fires in containers above hold four on the port side.

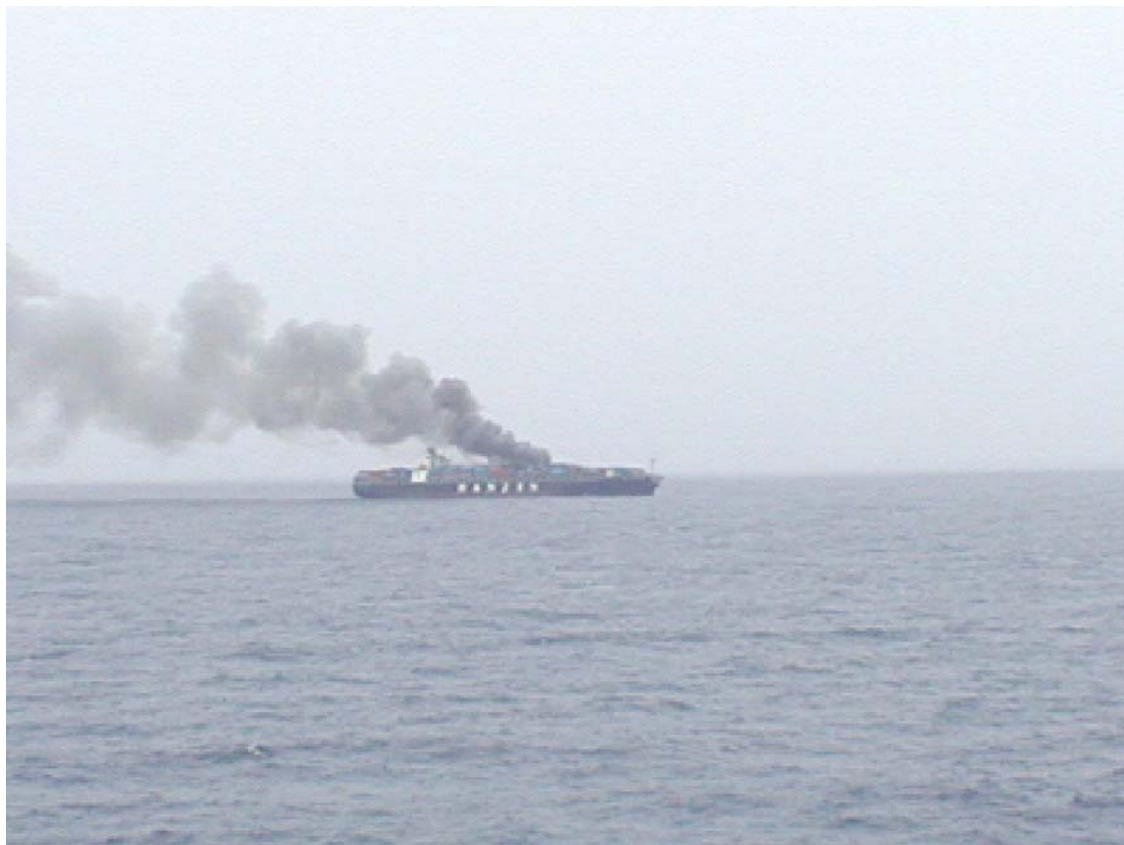
Photo 3. November 11th. M/V HANJIN PENNSYLVANIA (starboard) the morning of the first explosion above hold four. Fires continued to burn for 4-days and spread to containers above hold six forward of the accommodation.

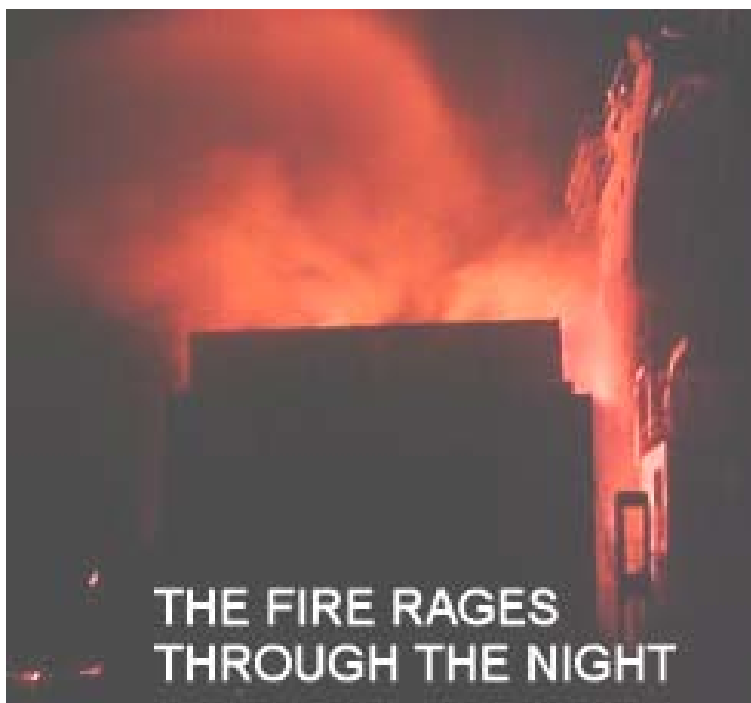
Photo 4. Containers above hold six and forward of the accommodation burning. Note the intensity of the fire and the location of the accommodation to the right.

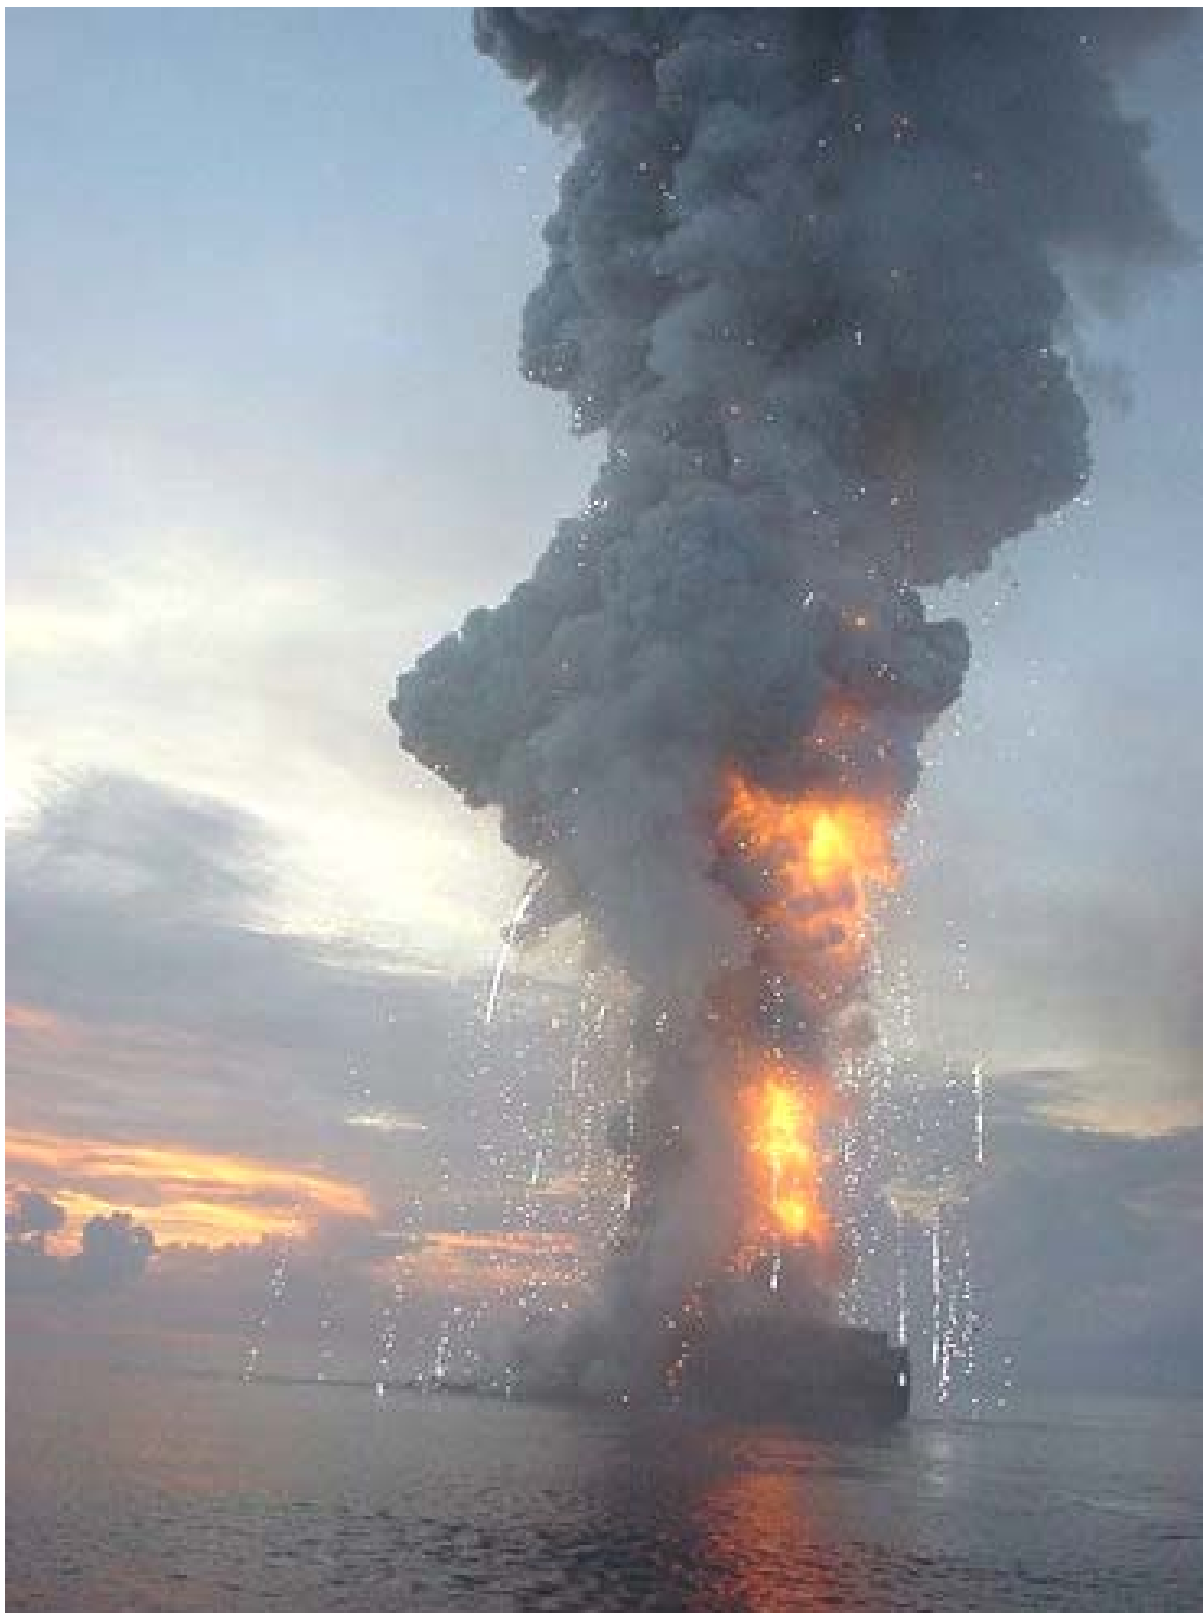
Photo 5. November 15th. The massive explosion in hold six aboard the M/V HANJIN PENNSYLVANIA. Note the large, rising orange fireball the tremendous plume of gray-black smoke and silver effects rising with the plume and then falling back to the sea.

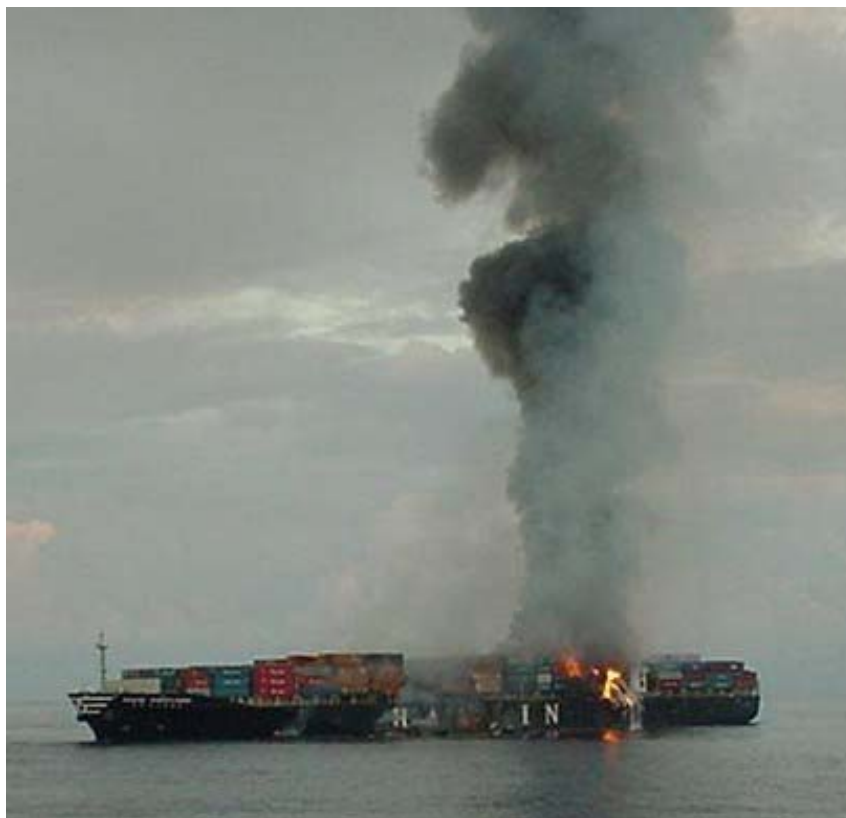
Photo 6. The M/V HANJIN PENNSYLVANIA (port) after the explosion of Nov 15th in hold six. Fires continue to burn above hold six and smolder above hold four. Note the missing containers above hold four and the plume of gray-black smoke from hold six.

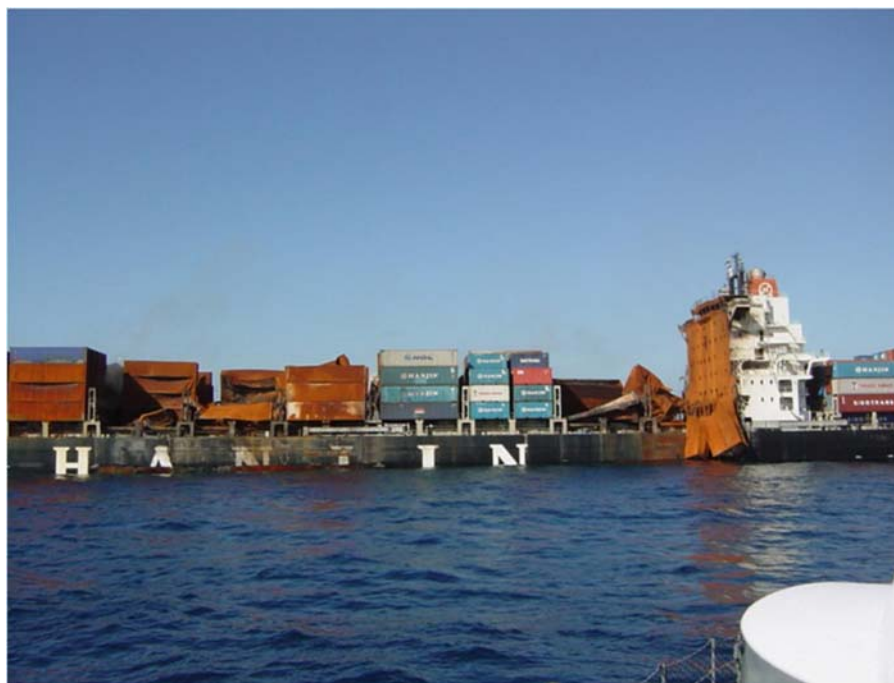
Photo 7. The M/V HANJIN PENNSYLVANIA (port) riding very low in the water as a result of fire fighting efforts. Note the burned containers above hold three and the missing and burned containers above hold four. Also note the raised and twisted deck hatch, the missing containers and heavy damage to the containers above hold six forward of the accommodation. Damaged containers above hold six are hanging over the port side

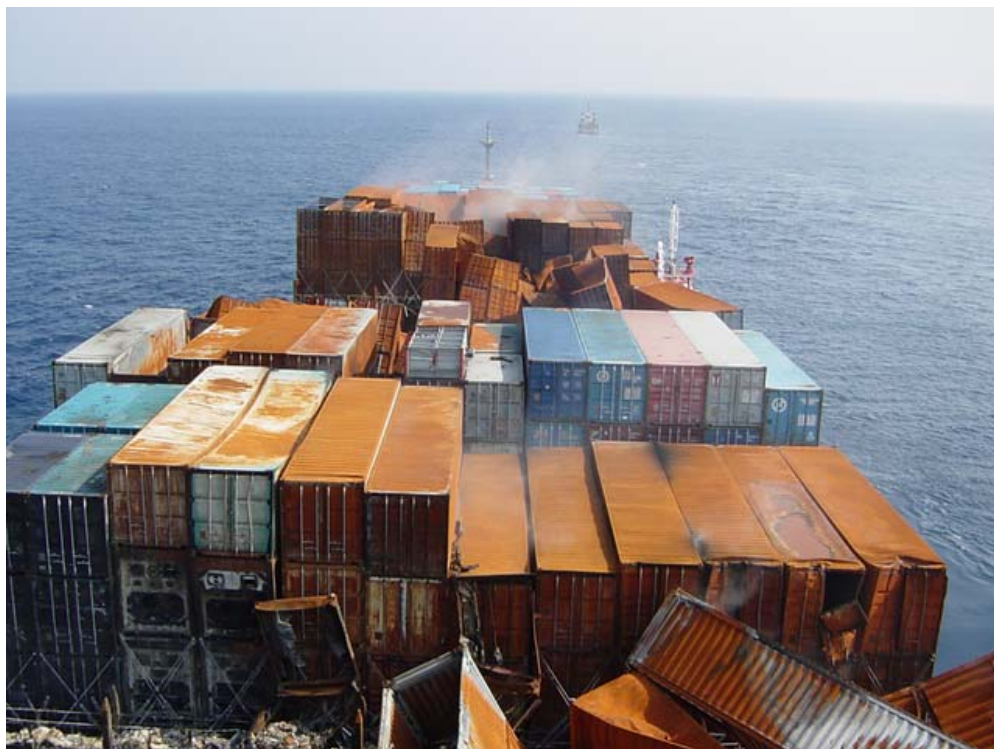
Photo 8. The view after Nov 15th from the accommodation of M/V HANJIN PENNSYLVANIA. Note the missing containers on the port side of hold 4 where the initial explosion occurred on Nov 11th.

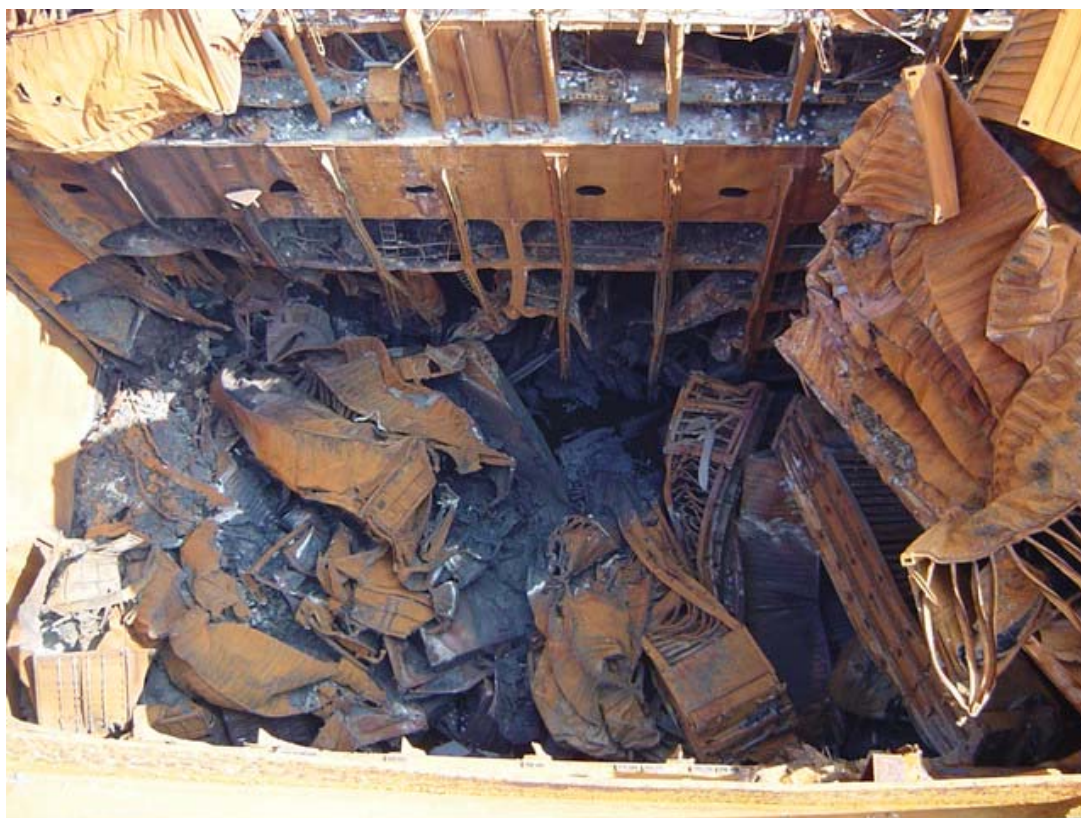
Photo 9. The aftermath of the Nov 15th explosion in hold six. Note the twisted wreckage here and compare to the containers above holds three, four and five.

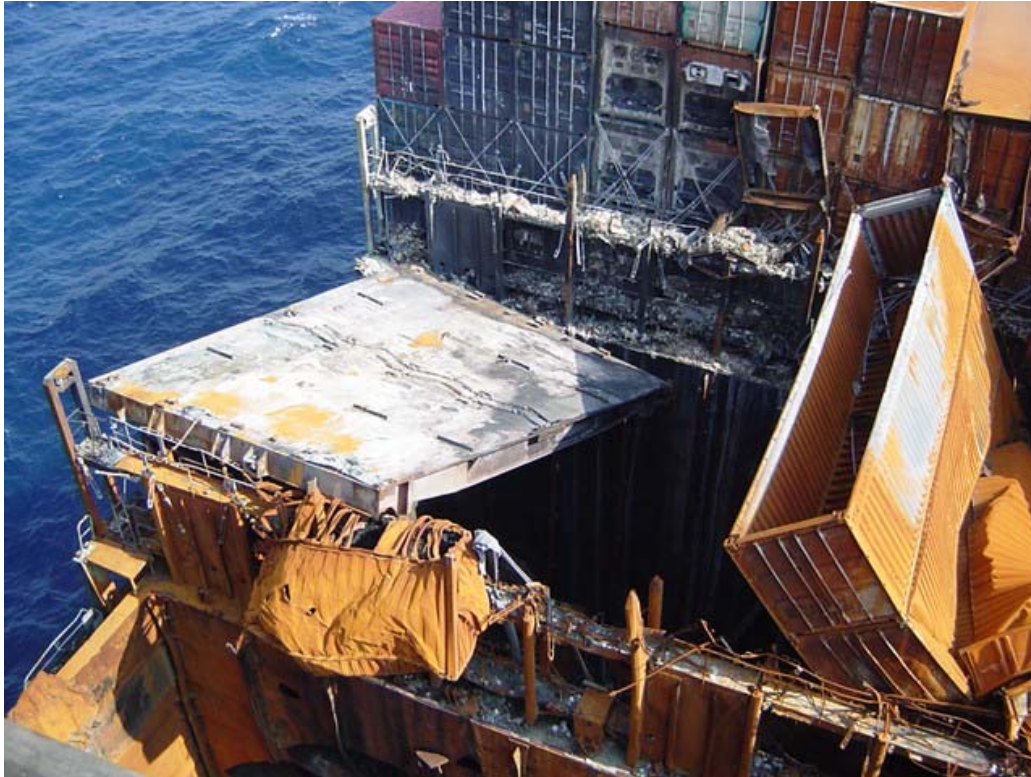
Photo 10. The aftermath of the Nov 15th explosion above hold six. Note the deck hatch (weight approximately 30 tons) that is normally held in place by a series of heavy pins.

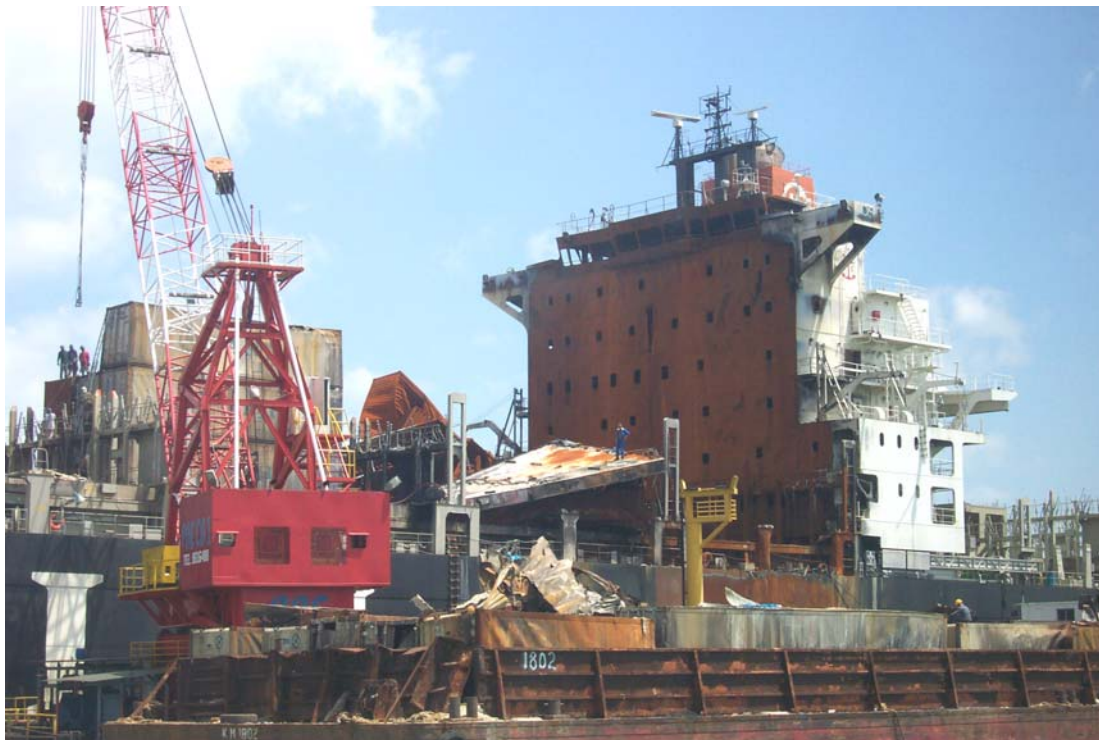
Photo 11. The M/V HANJIN PENNSYLVANIA (port) in Singapore during salvage and recovery operations. Note the twisted and upraised deck hatch now resting in the port side forward rack above hold six. The deck hatches from the port side and center racks in the aft rack of hold six are missing.

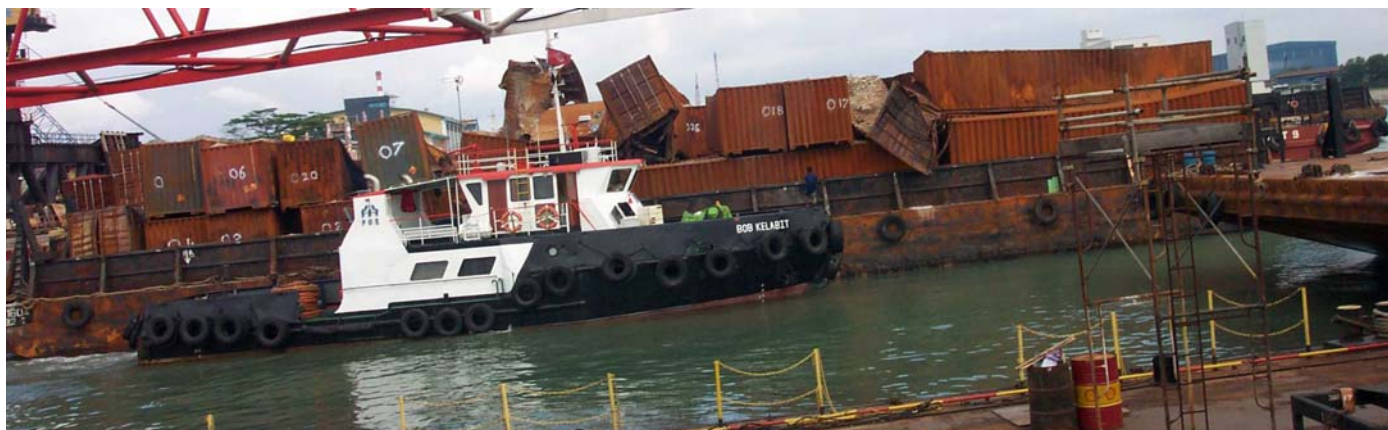
Photo 12. A barge in a Singapore salvage yard with burned out containers from M/V HANJIN PENNSYLVANIA. Note the orange 1.4G placards on the containers to the left (0#, 06 and 07) that curiously survived in spite of the fact the paint did not.

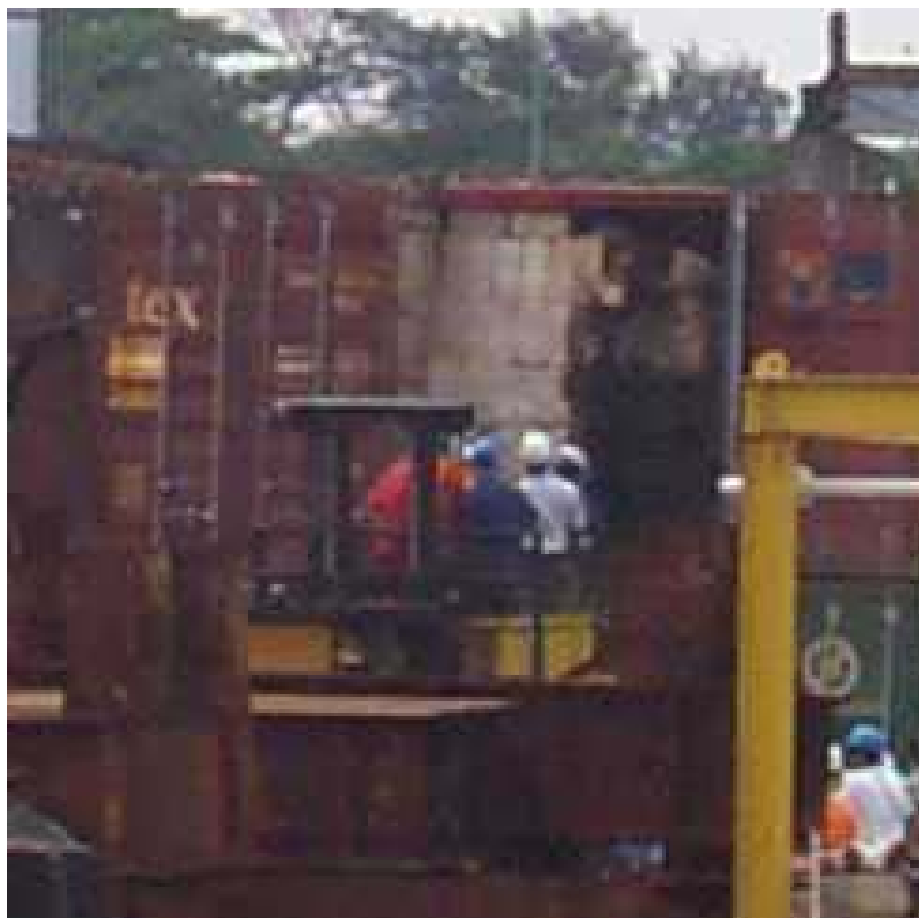
Photo 13. A container with fireworks from the M/V HANJIN PENNSYLVANIA is surveyed in Singapore. Note the cartons to the right and nearest to the door have heavy fire damage but the cartons to the left do not. A motorized forklift is being used to lift the General Average and some surveyors to view the top tier of over 50 containers of fireworks. About 20 other people viewed this from the ground. Cutting and grinding as well as other metal salvage operations continued in the vicinity of this busy salvage yard. These containers were handled from the ship to the salvage yard despite the fact many of these containers were water logged from the fire fighting efforts and had been exposed in the equatorial sun for over a month.

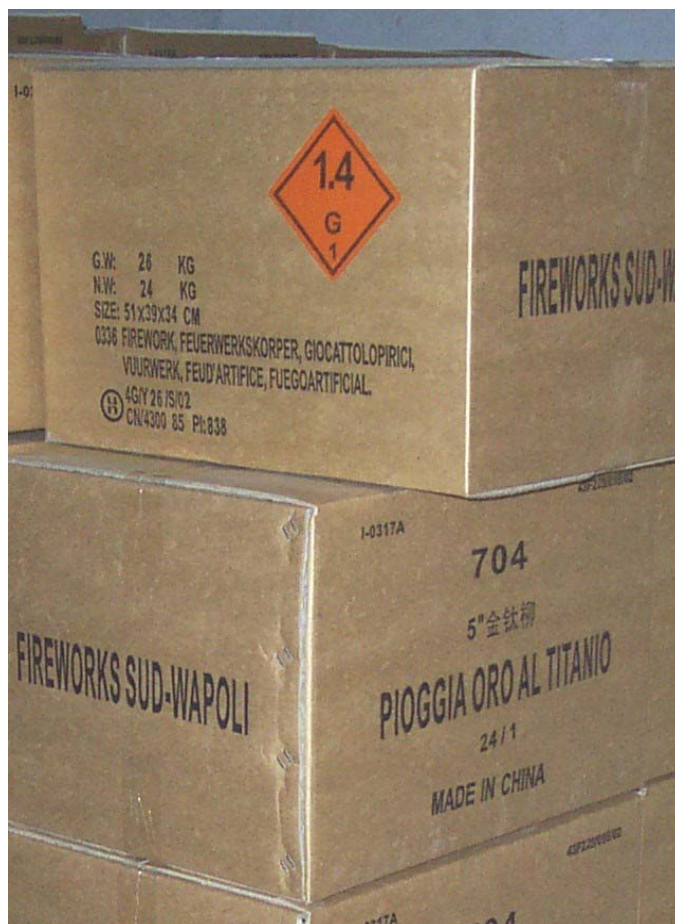
Photo 14. A warehouse full of 5” and 6” aerial fireworks shells in a Chinese warehouse await shipment to a European customer. Note the 1.4G classification and the various European language descriptions on the top carton of 5” aerial shells. These same aerial fireworks would be classified as 1.3G if shipped to the United States and other markets.

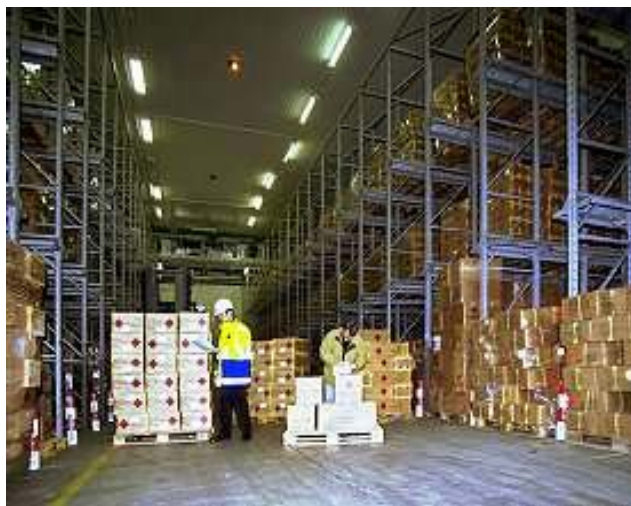
Photo 15. A distribution warehouse utilizing rack storage for imported 1.4G fireworks in Hamburg, Germany. No sprinkler system is apparent and the stacks of cartons on these pallets are not stabilized. Electrical systems do not appear to be explosion proof and motorized equipment is clearly used to move the pallets of fireworks. Distances from this building to other buildings and public areas is not known.
