M/V Hanjin Pennsylvania: Explosions at Sea

Charles P. Weeth
Weeth & Associates, LLC
122 S 17th St.
La Crosse, WI 54601-4208 USA

Final Report - Pictures

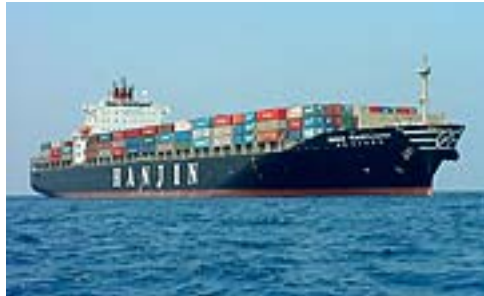
Photo 1. The newly built M/V HANJIN PENNSYLVANIA (starboard) fully loaded with containers. Holds one-six are from the bow to the accommodation, holds seven and eight are from the accommodation to the stern. Note how high in the water the ship is in this picture.
